## Red Cedar Island RipRap description

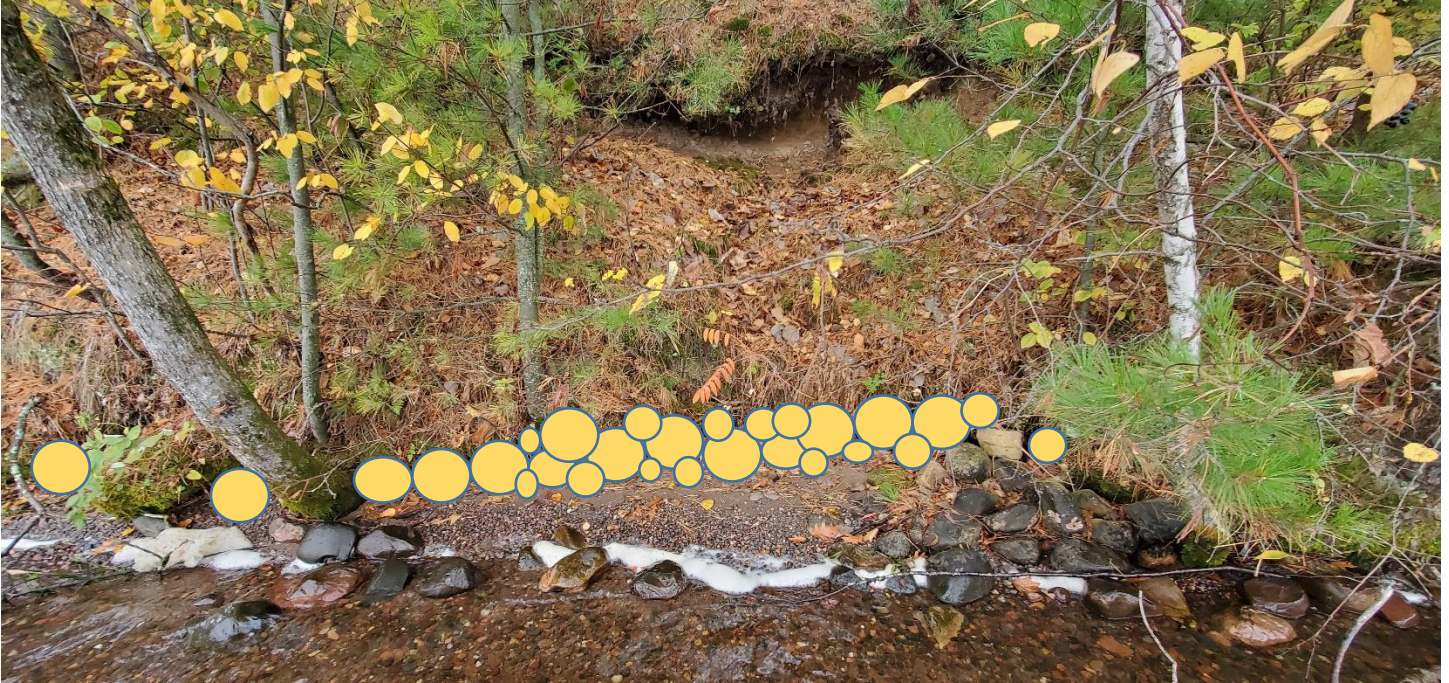
These photos were taken in the fall after the lake level had been dropped 4-6" from summer levels. Riprap will be placed in the undercut, which in these photos is above the waterline.

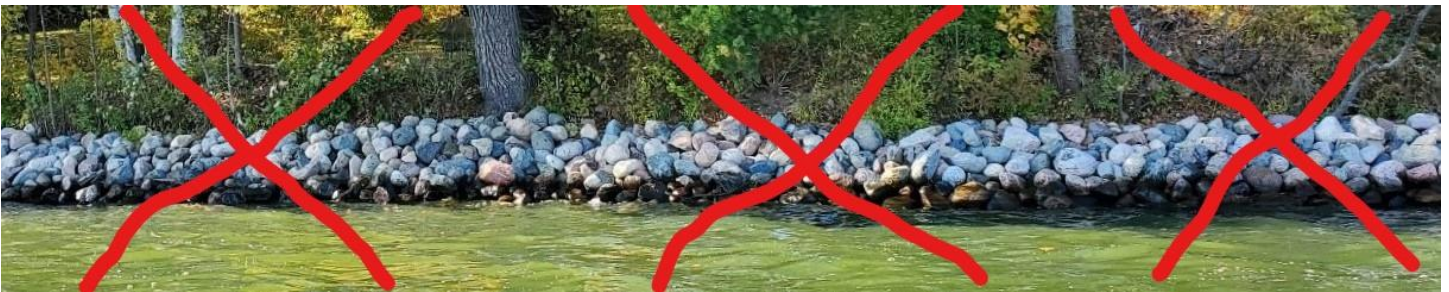
The erosion is occurring at the summer waterline. A single layer of 12-16" stones with some smaller ones used to fit into the gaps will be placed tight to the undercut. This design will be used on all areas of rip rap

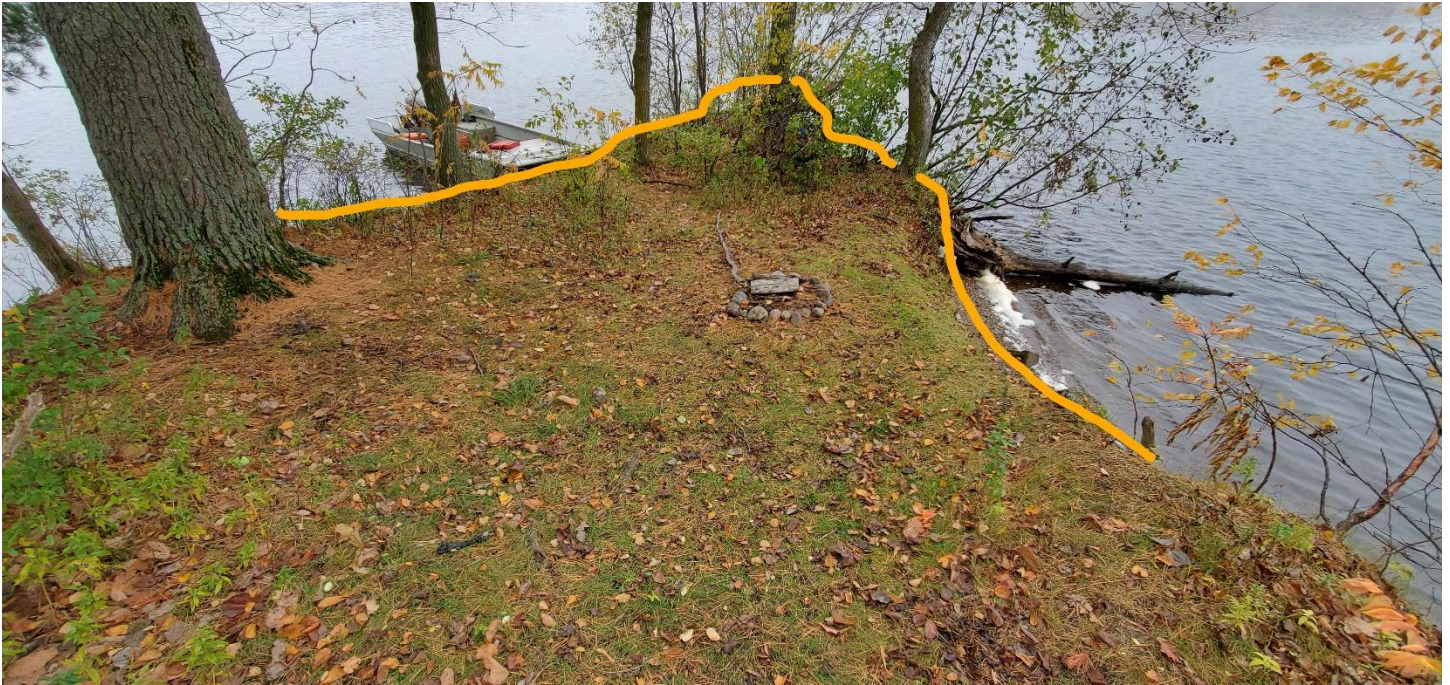
On the west end of the island the riprap will extend from the large white pine around the tip.

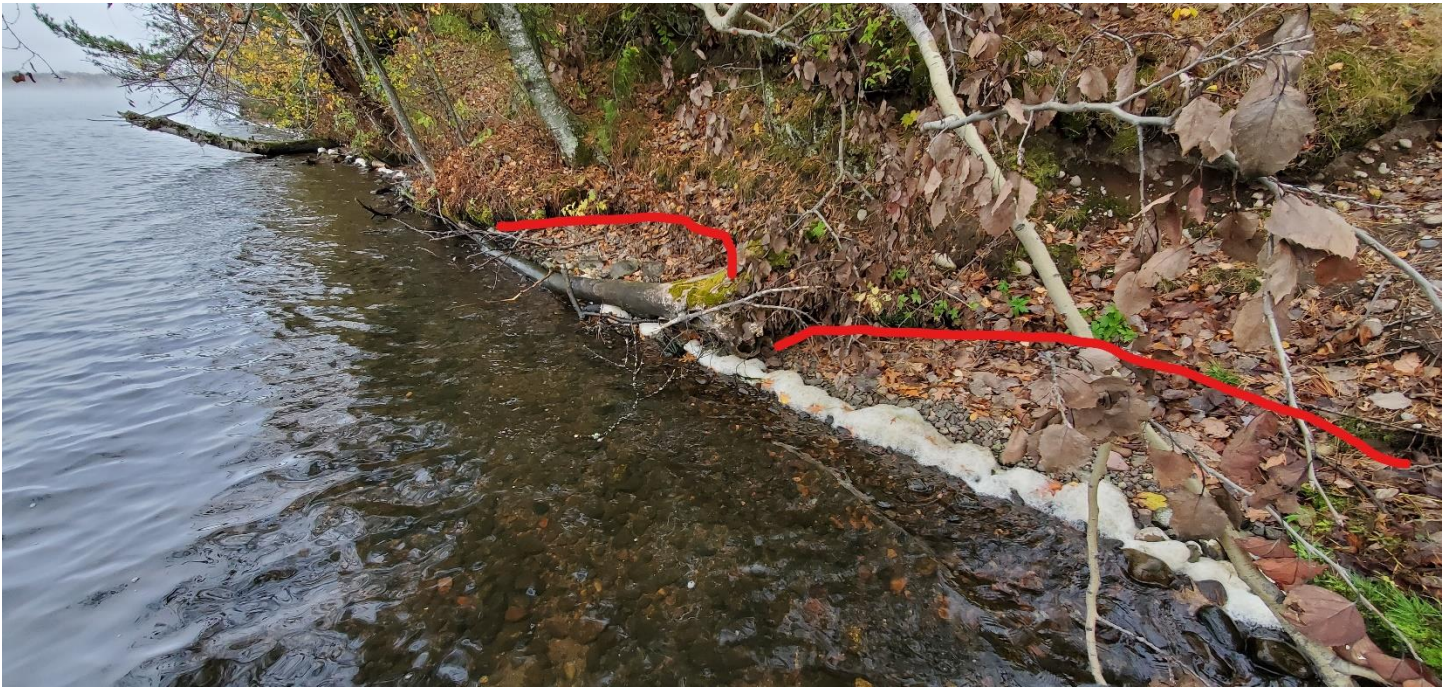
This is a view of the west end. The rock will extend around the tip.

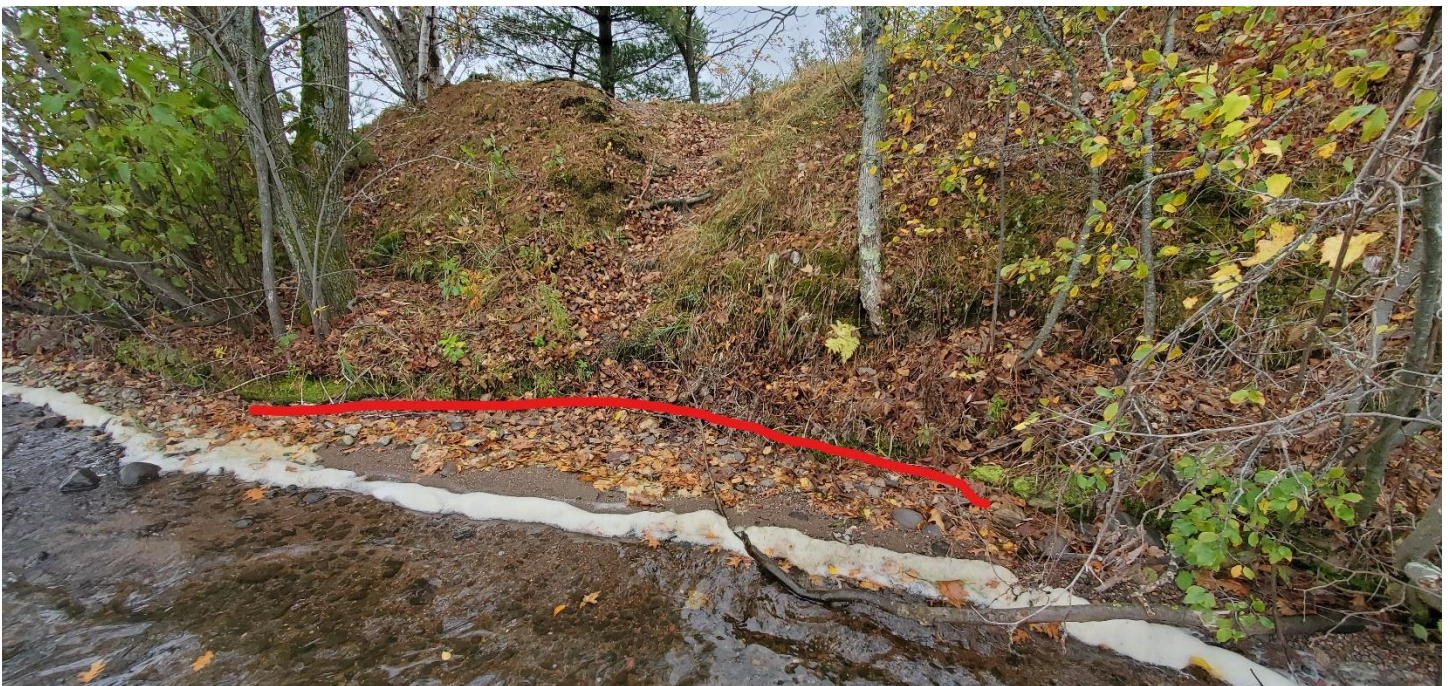
There are several areas along the north shore where the waves have cut into the bank where rip rap will be placed.

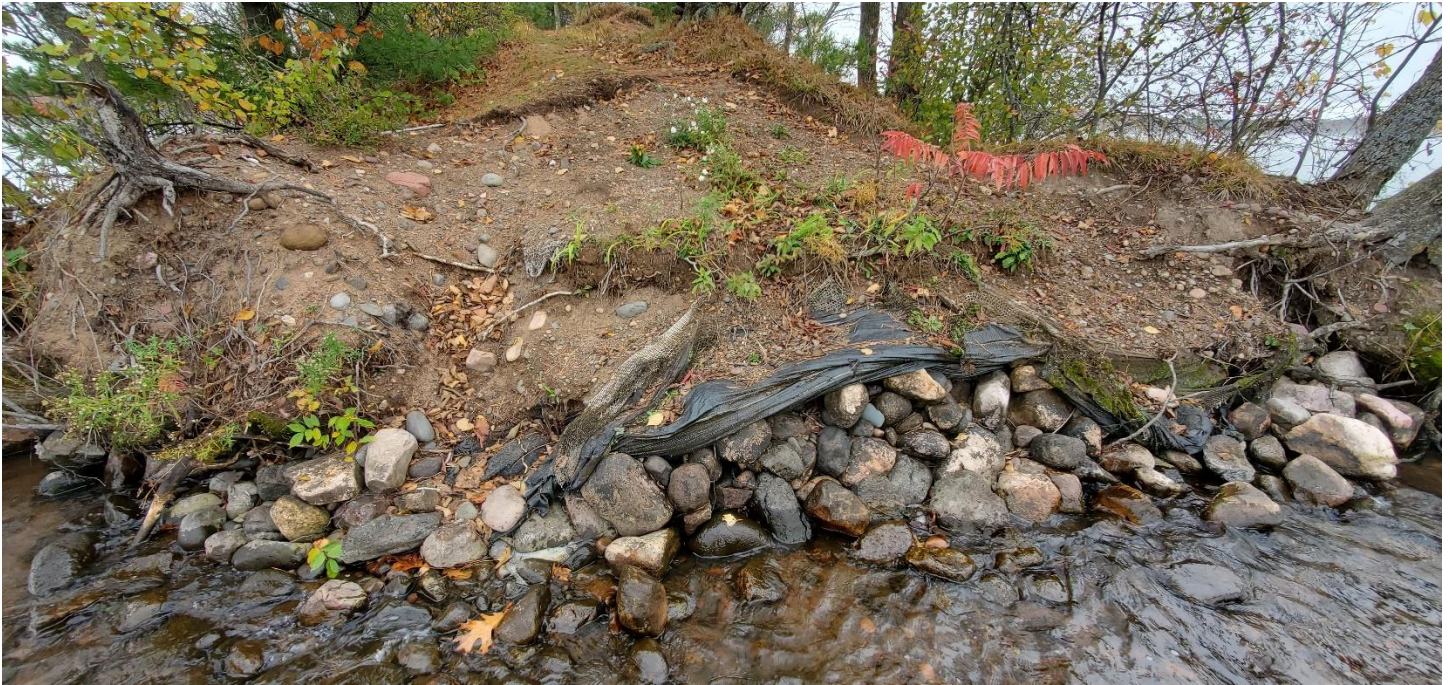
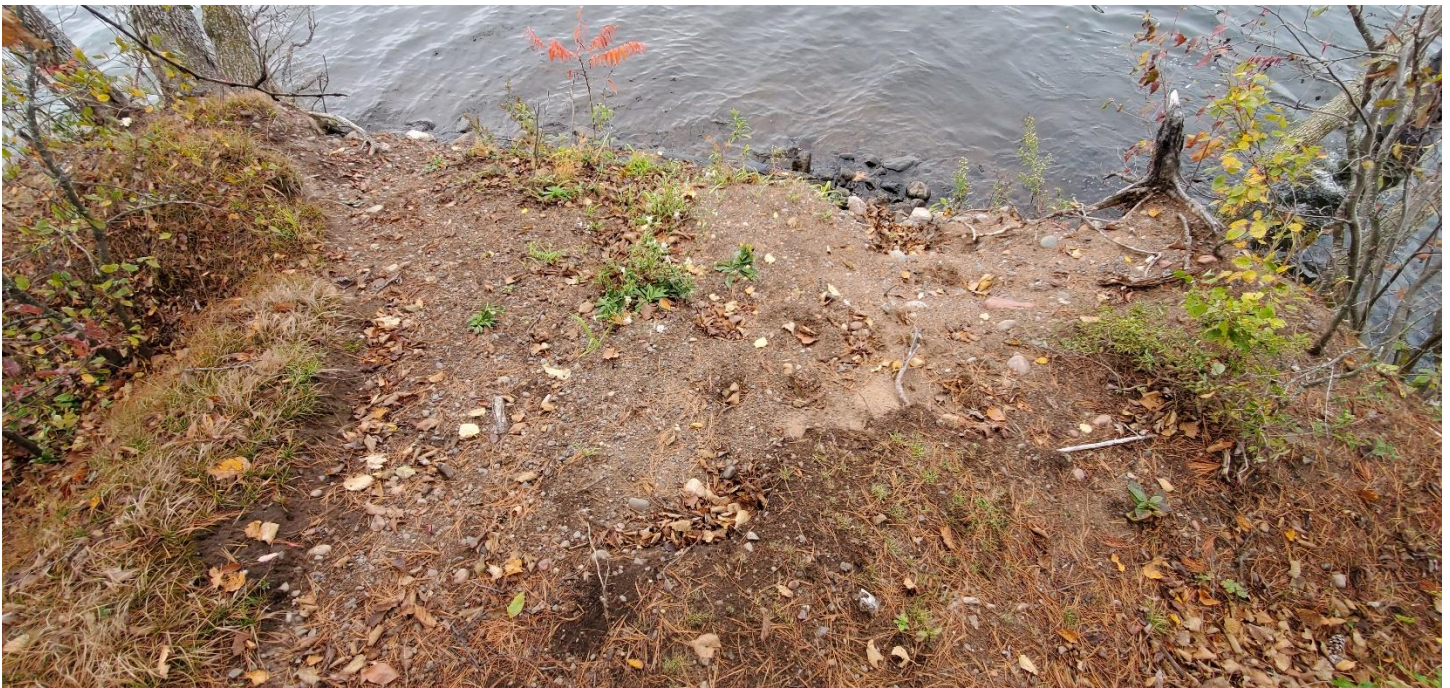
This location on the NE corner of the island will have a row of rip rap will be placed along with a rope barrier to limit foot traffic up onto the island.

The east end of the island has adequate rock from previous attempts at stabilization, however the foot traffic has eliminated the topsoil and it is severely eroding. It is approximately 350 ft<sup>2</sup>

There is approximately 170' of riprap needed.

Averaging a 1.5' x 1.5' cross section of riprap, this would be 15 cubic yards of rock

The area will have any loose debris raked out and then 4" of topsoil placed – 4 cubic yards.

It will then be seeded with a native erosion control seed mix. <https://www.prairienursery.com/erosion-control-seed-mix-for-dry-soils.html>

A double netted erosion control blanket (4' wide roll) will be installed over it with 6" sod staples every 18"

In order for this to work, access will need to be restricted to the west end of the island. Rope fencing with signage explaining the process will need to be installed.

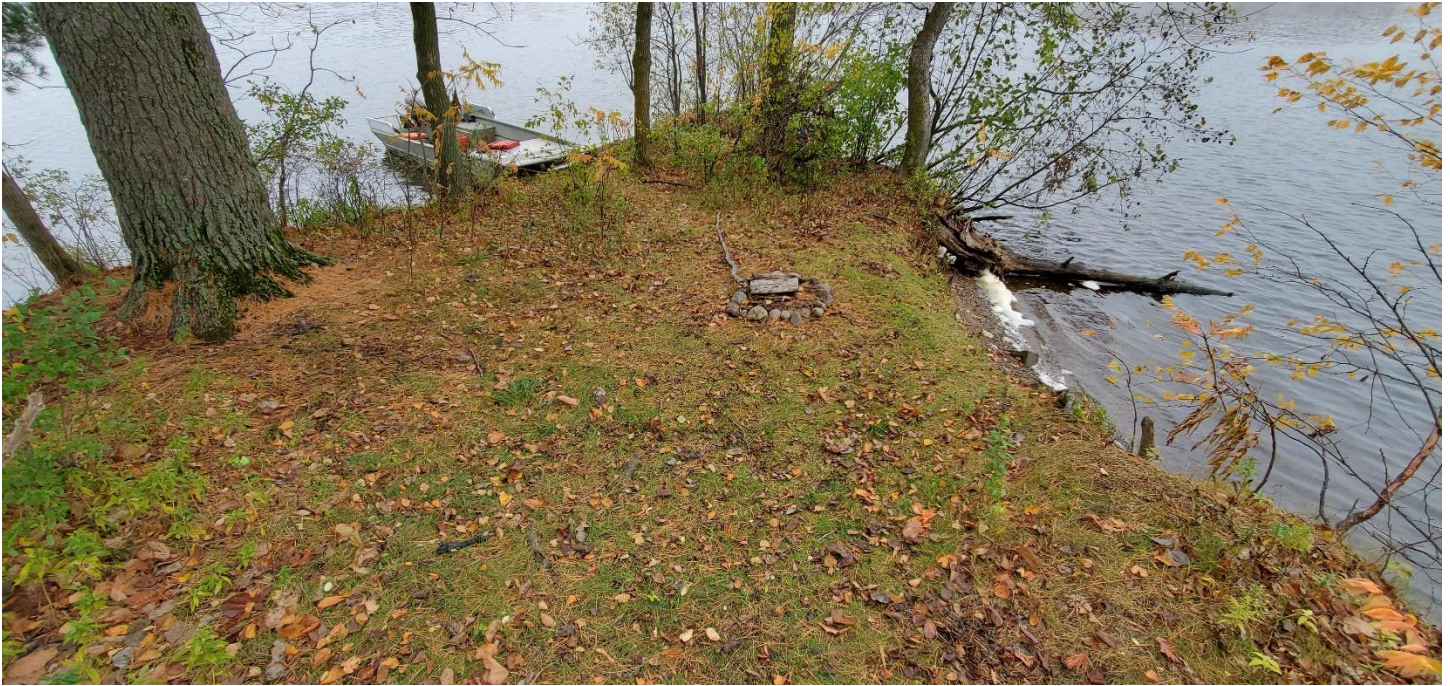
Access would be allowed in this area. (photo looking west)

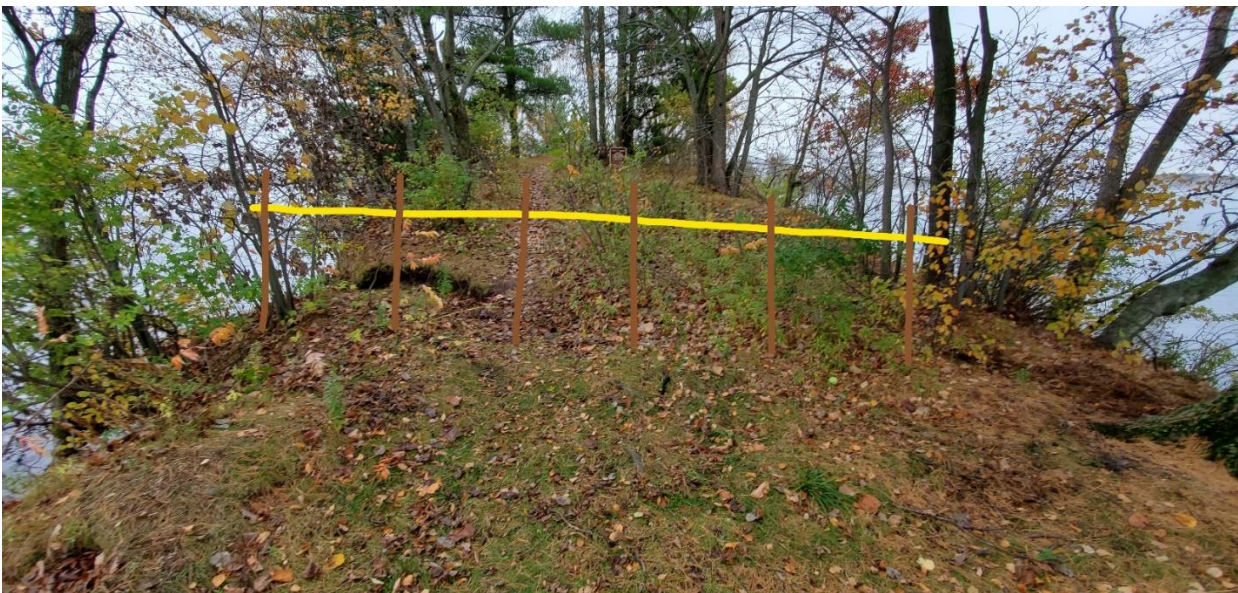
A rope barrier would be installed along with a sign at the east end of the flat grassy area. (photo looking east)

Rope barrier will be needed also on the east end and other areas.
