RED CEDAR LAKES, BARRON & WASHBURN COUNTIES

BALSAM-MUD
(2112800)
BASS (1833100)
RED CEDAR (2109600)
HEMLOCK (2109800)
MURPHY FLOWAGE
(2110900)

2024-2033 Comprehensive Lake and Watershed Management Plan

Prepared by: Dave Blumer & Megan
Mader, Lake Education and Planning
Services (LEAPS)

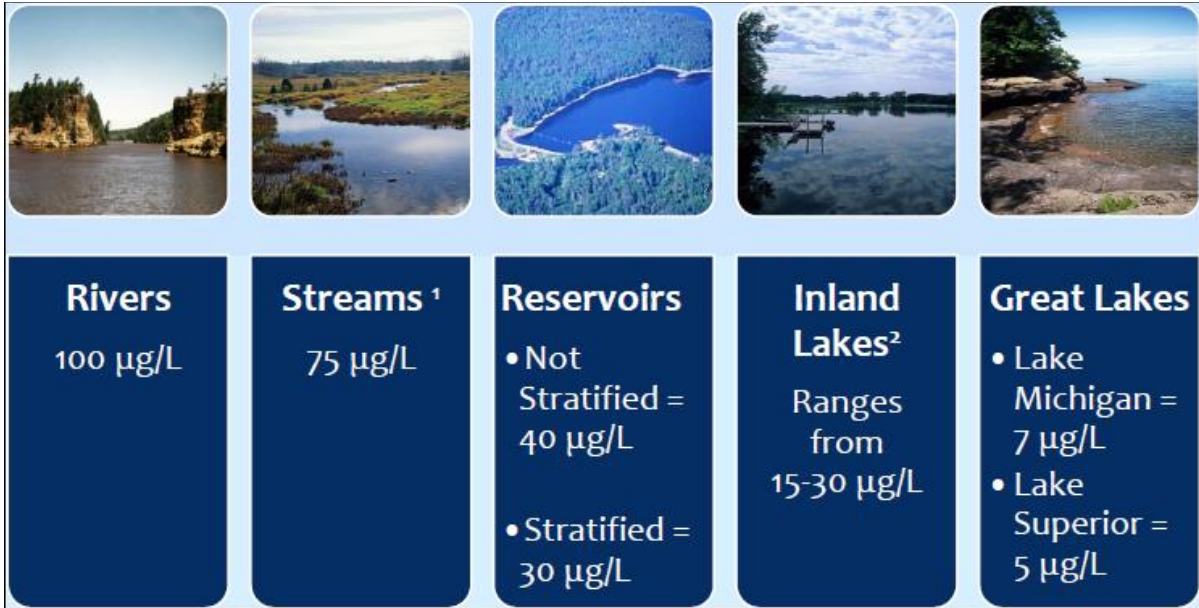
Figure 1: Wisconsin numeric water quality standards for phosphorus (WDNR, 2018)

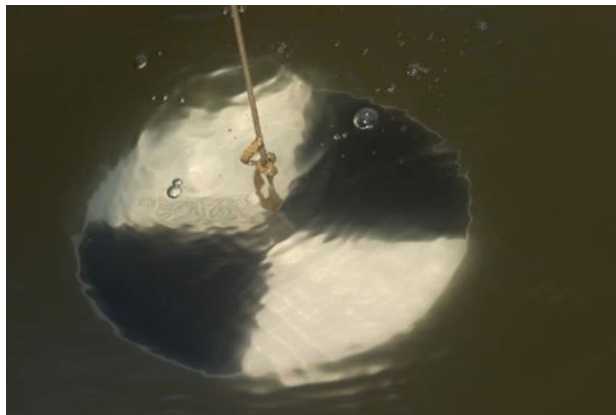
798
799 **Figure 5: Secchi disk**

788 **3.2.1 Water Clarity**
789 Water clarity is a measurement of how deep sunlight can penetrate into the waters of a lake. It can be
790 measured in a number of ways, the most common being an 8” “Secchi” disk divided into four sections, two
791 black and two white, lowered into the lake water from the surface by a rope marked in measurable increments
792 (Figure 5). The water clarity reading is the point at which the disk when lowered into the water can no longer
793 be seen from the surface of the lake. Water color (e.g. water stained by tannins from nearby bogs and
794 wetlands), particles suspended in the water column (e.g. sediment or algae), and weather conditions (clouds,
795 wind, or sunlight) can impact how far down a Secchi disk can be seen in the water. Some lakes have Secchi
796 disk readings of water clarity of just a few inches, while other lakes have conditions that allow the Secchi disk

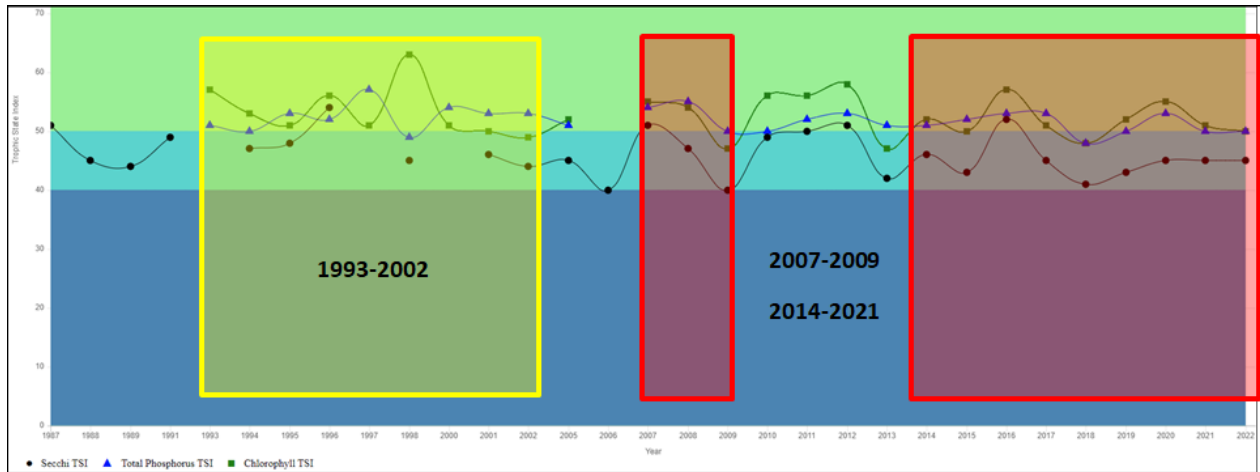
1017
 1018 **Figure 12: TSI values for Red Cedar Lake - North Basin Deep Hole (black circles – Secchi TSI, blue**
 1019 **triangles – TP TSI, and green squares – Chla TSI)**

1015 In 1998, from 2010 to 2012, and again in 2016, TP and Secchi values are similar, and Chla is higher than both.
1016 This pattern is not defined by Carlson and Havens.

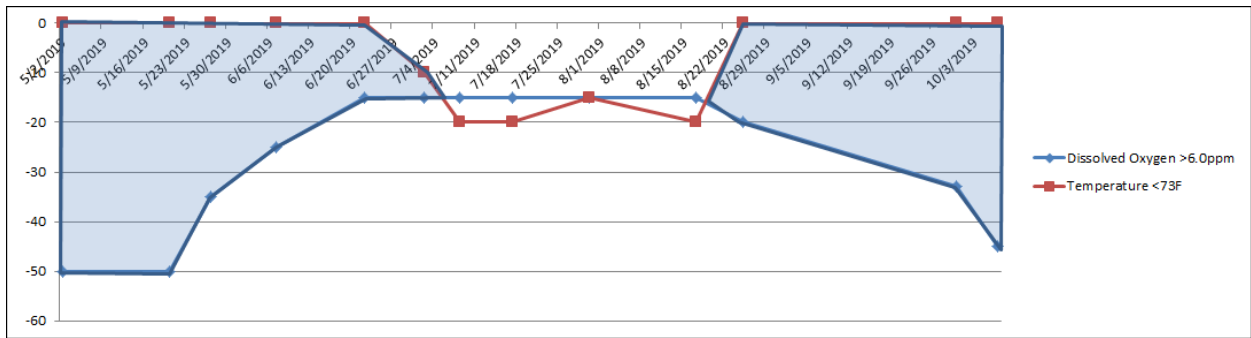
Figure 21: 2019 Cold water fishery in Red Cedar Lake North Basin

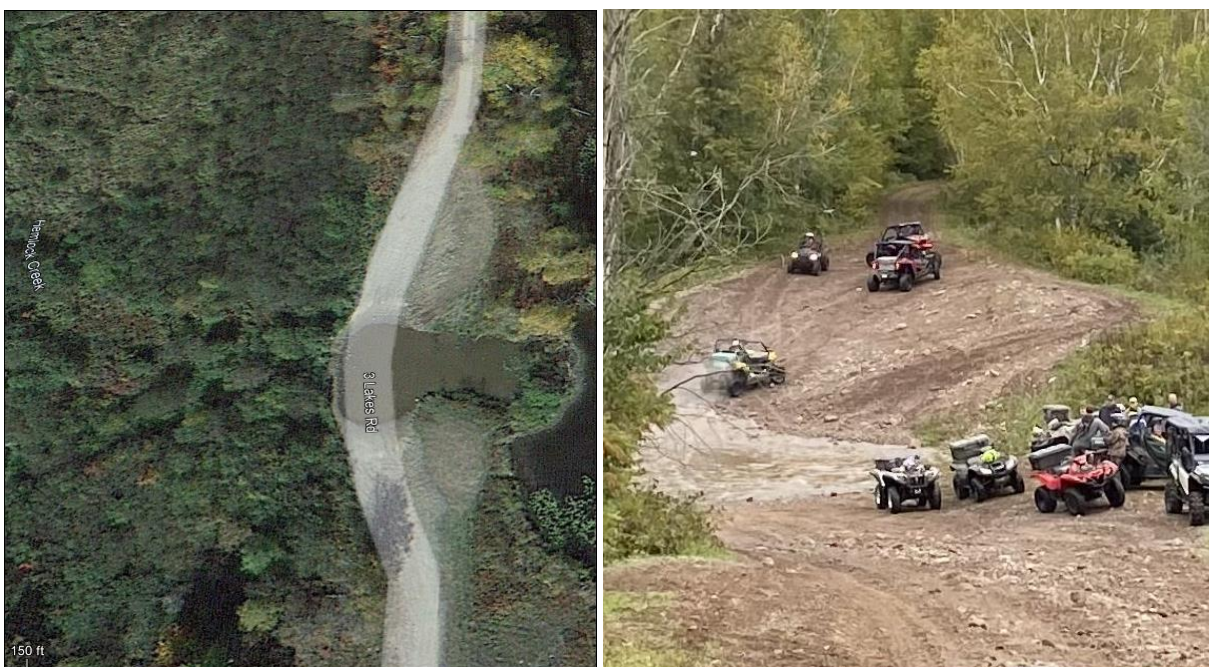
1857
1858 **Figure 50: Hemlock Creek ATV Crossing on 3-Lakes Road in the Rusk County Forest. (Left - Sept.**
1859 **2012; Right – Sept. 2022)**

1611 would drive through the pool of water created by the crossing again and again. Sediment laden water leaves
1612 the pool and continues downstream in Hemlock Creek, into Bucks Lake and on downstream. While the water
1613 may not flow 100% of the time, when it does, a large amount of sediment and phosphorus in the water can
1614 be expected.

1854 There may be other ATV trail stream crossings on the Rusk County (and Barron, Sawyer, and Washburn
1855 Counties) forest ATV trail system with similar issues, but this one in particular is likely contributing to water
1856 quality issues.
